THE HADLEY OVERPASS PROJECT

Taking the "Stress" out of Bridge Repairs

By Matt Yerkey, P.E.

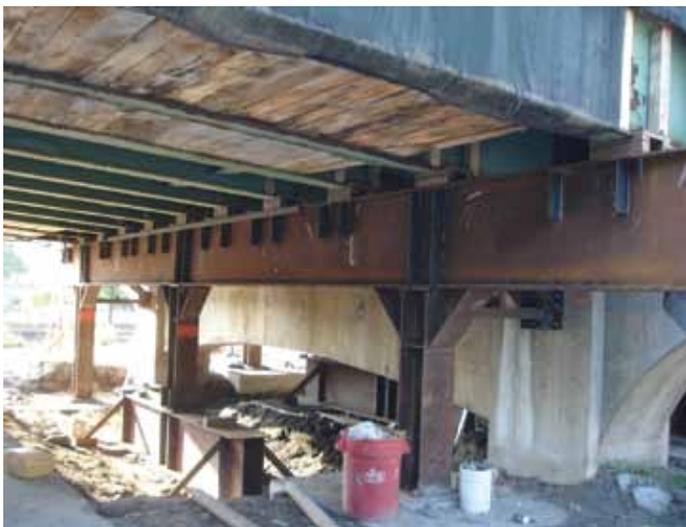
Figure 2. Span 9 shoring via steel moment frames.

Conventional engineering was required for several facets of the project. The superstructures for spans 7, 8, and 9 were shored with steel moment frames founded on cast-in-place concrete footings (Figure 2). In addition, existing substructures were shored during concrete repairs using towers, and the construction engineer designed utility supports to span unbraced from pier to pier, designed temporary lateral-bracing systems to permit existing truss bottom lateral-bracing retrofits (Figure 3), and developed procedures for the systematic replacement of the existing truss end sway frames. The main trusses were also lifted and shored so that each bearing (520-kip design lifting load) could be removed and replaced.

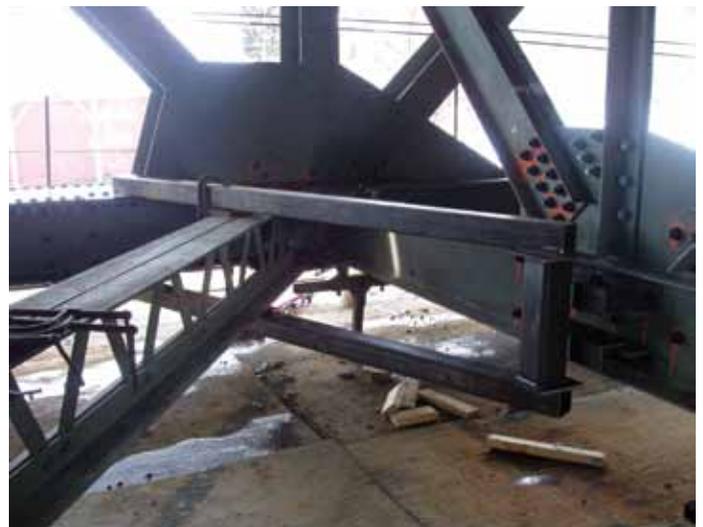
Figure 3. Bottom lateral retrofit shoring.

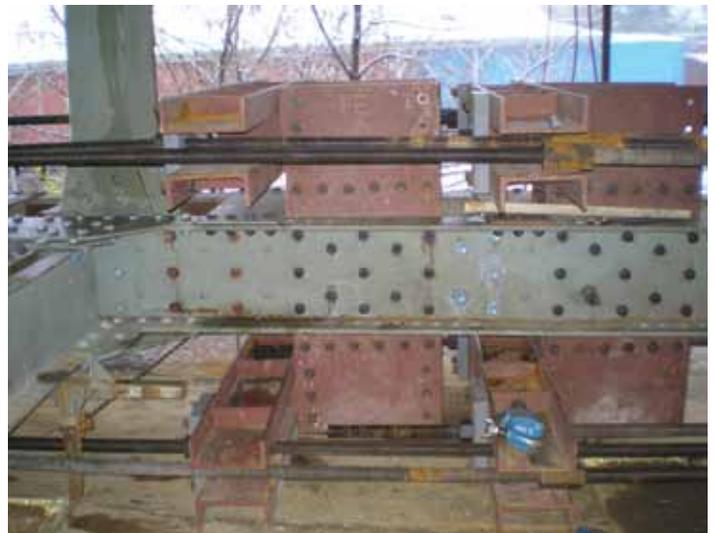
Figure 6. Vertical transfer plate as constructed.

total capacity). The multi-setup system also proved advantageous for connecting the vertical load transfer plates to the existing main truss bottom chord. The smaller the vertical transfer plates, the easier it was to find symmetric locations on either side of the panel point to install the vertical transfer plate while avoiding the existing bottom chord top and bottom stay plates. In addition, the owner wanted as few new holes in the existing bottom chord as practical for the connection of these temporary components to the existing bottom chord; therefore, existing rivets were removed and replaced with high-strength bolts. All of the existing rivet spacings were field-measured so that the bulk of the components

could be shop-fabricated. The vertical transfer plates served as thrust points against which the hydraulic rams could ultimately pull (Figures 5 and 6, page 39).

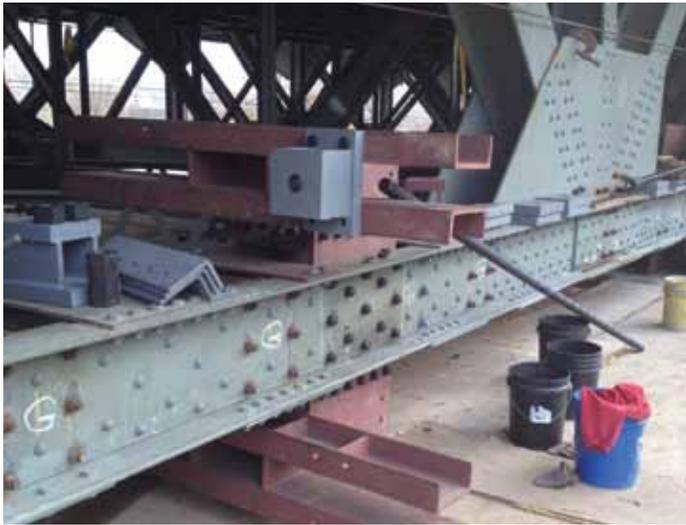
Figure 7. Transfer plates and channels.

Upper and lower horizontal transfer channels were installed at each vertical transfer plate, which projected both above and below the bottom chord. The horizontal transfer channels projected both to the inboard and outboard of the existing main truss bottom chord. This would keep the threaded tie rods out away from the panel point, giving the contractor room to remove and replace the splice plates. In addition, the horizontal transfer channels at the first, second, and third setups projected progressively longer

so that the threaded tie rods could pass by those from the preceding setup. Ultimately, each transfer channel was connected to its sister on the opposite side of the panel point with 2-inch-diameter, 150-ksi threaded rod (Figures 7 and 8).

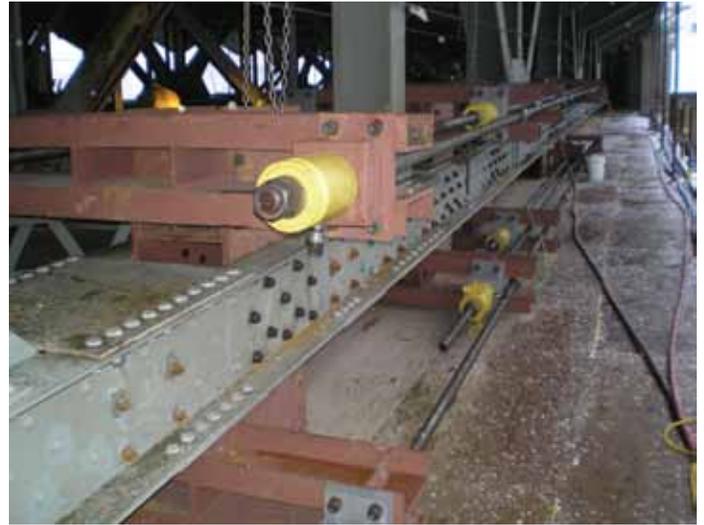
Figure 8. Hydraulic rams and threaded rods.

There were four threaded rods per setup: upper outboard, upper inboard, lower outboard, and lower inboard. Four 60-ton hollow-cylinder rams “stretched” each of the threaded rods to specific pressures depending on the panel point being worked. Hydraulic manifolds ensured uniform pressure distribution. Tensioning of the rods compressed the bottom chord, thus counteracting the existing axial tension force, and in turn bringing the existing main truss bottom chord to a near zero state of stress at the panel point (see Figures 9 and 10 for before and after ram pressurization).
